BRANZ **FIRE TEST REPORT**

FF13923-01

**BS 8414-2:2015+A1:2017 TEST OF EQUITONE T50 FAÇADE SYSTEM
IN ACCORDANCE WITH BR 135 ANNEX B CRITERIA**

The Building Agency
14 Link Drive
Wairau Valley
Auckland, 0627
New Zealand

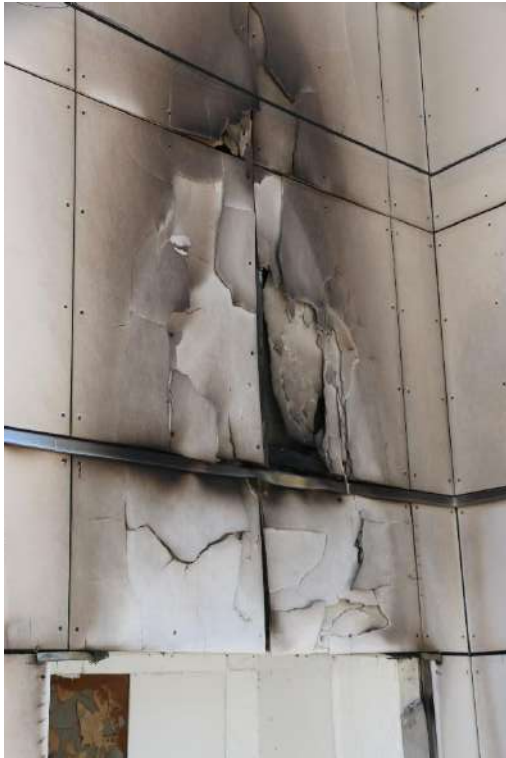
Photo 1: Cladding material

(Located above combustion chamber opening).

Two columns of cladding sheets above the combustion chamber opening delaminated where directly impinged by flame. There was discolouration, fissures and spalling up to 3.2 m above the chamber head (below mid-wall drainage flashing). The surrounding cladding surfaces were discoloured by smoke.

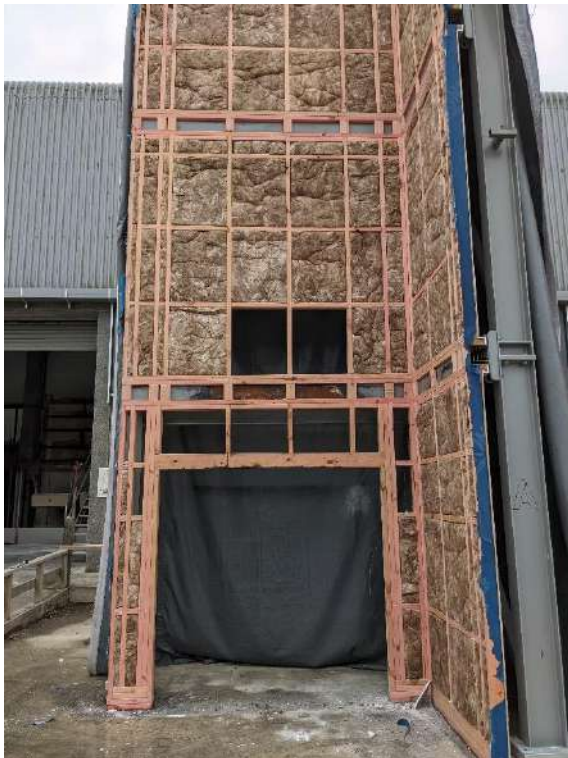
Photo 2: Timber frame and insulation
(Missing sections of insulation removed by BRANZ post-test).

The timber frame lintel edge was charred nominally 20 mm along the back edge and discoloured with slight charring along the right-side half of the front face edge. A 100 mm long section of the timber exposed by the rigid wall barrier expansion gap 700 mm above the combustion chamber opening was discoloured by heat.

There was no charring or flame damage on the unexposed plasterboard lining or internal surface of the rigid air barrier (within frame cavity). There was no damage to the insulation or within the timber frame cavity.

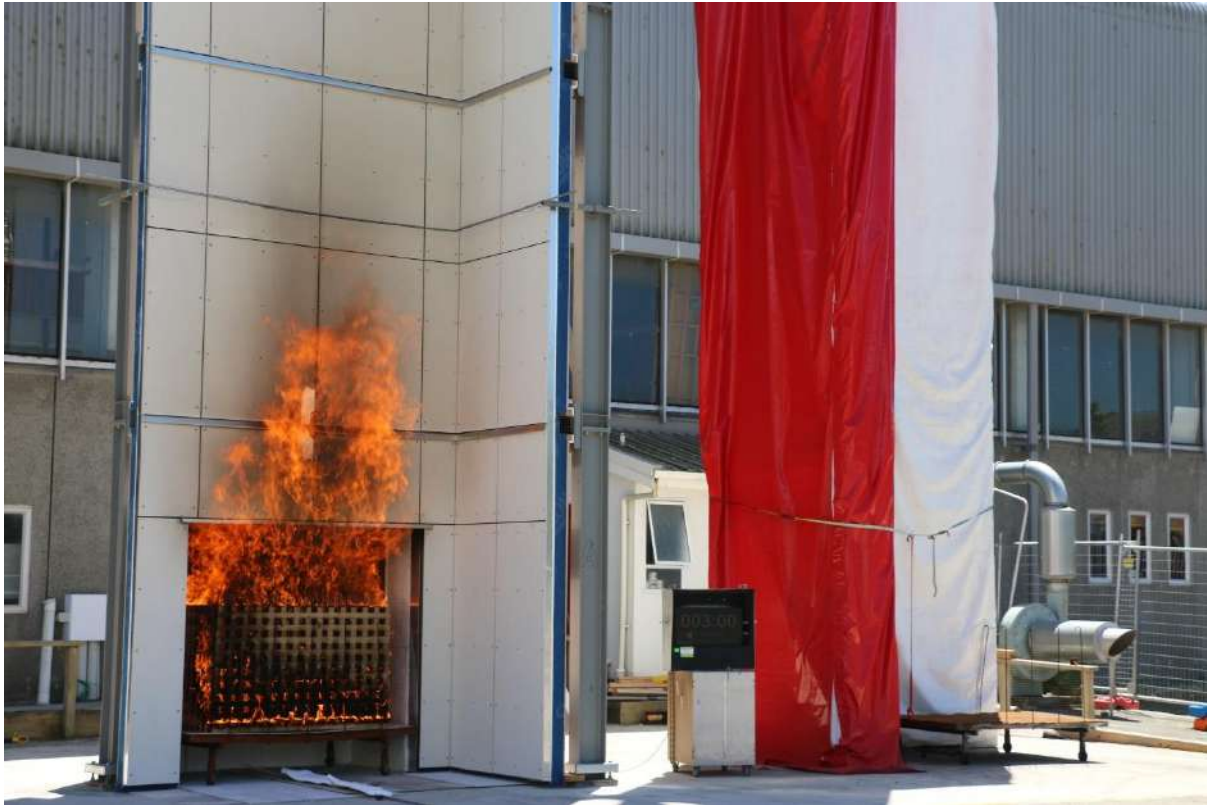
Photo 22: At 3 minutes 0 seconds

02:45	Spalling of cladding panel 600 mm above chamber opening. Delamination of 0.2 x 0.2 m sections of panel above, and below the drainage cavity flashing.

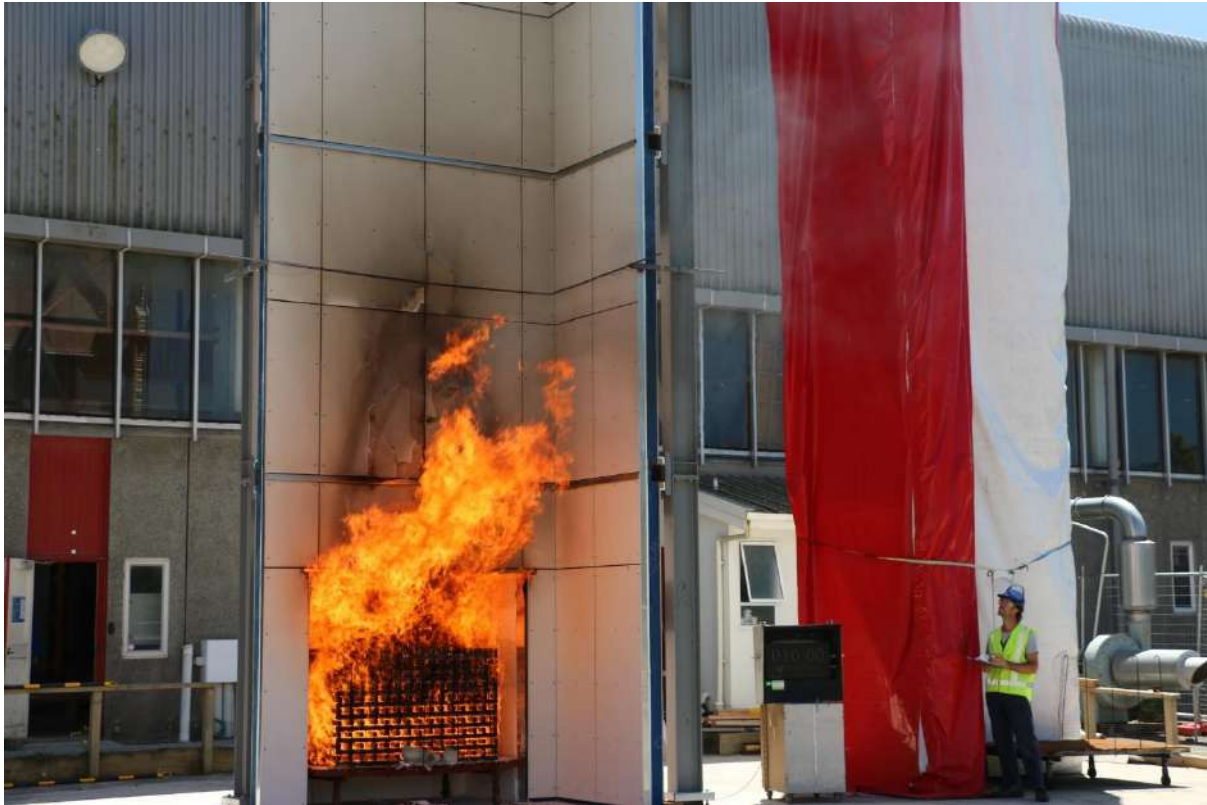
Photo 26: At 10 minutes 0 seconds

10:00	Equitone panel on the wing wall adjacent to the combustion chamber head has begun to spall and crack.
11:55	Smoke expelled from the main wall drainage channel, 3 m above the chamber.

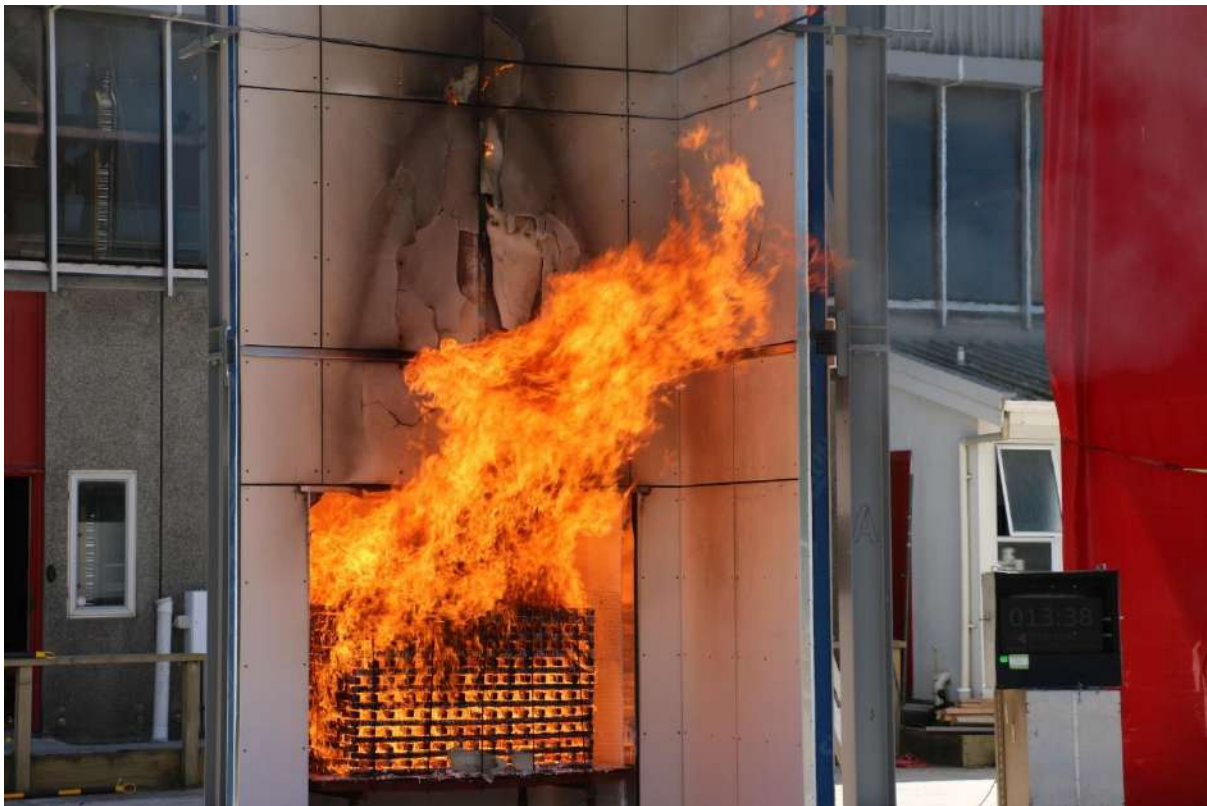
Photo 27: At 13 minutes 38 seconds

13:00	Sustained flaming on the main wall face, 2 m above the combustion chamber.
13:34	Continued spalling of cladding panel directly within the flame plume. A fissure has developed between the central cladding panels junction with sustained flaming 2 m above the drainage cavity.

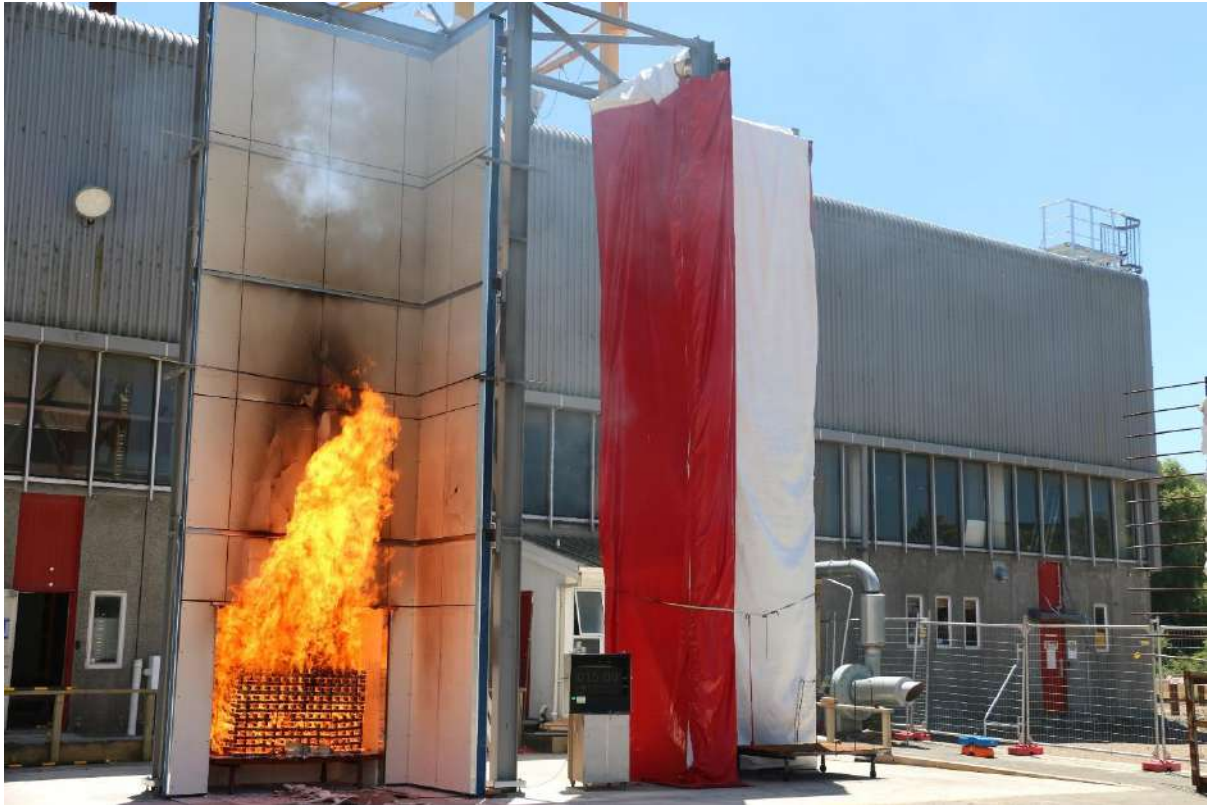
Photo 28: At 15 minutes 0 seconds

15:00	Smoke has begun to expell from the parapet capping at the top of the main wall.
17:30	Flaming debris from timber crib burns on ground at the base of the main wall.

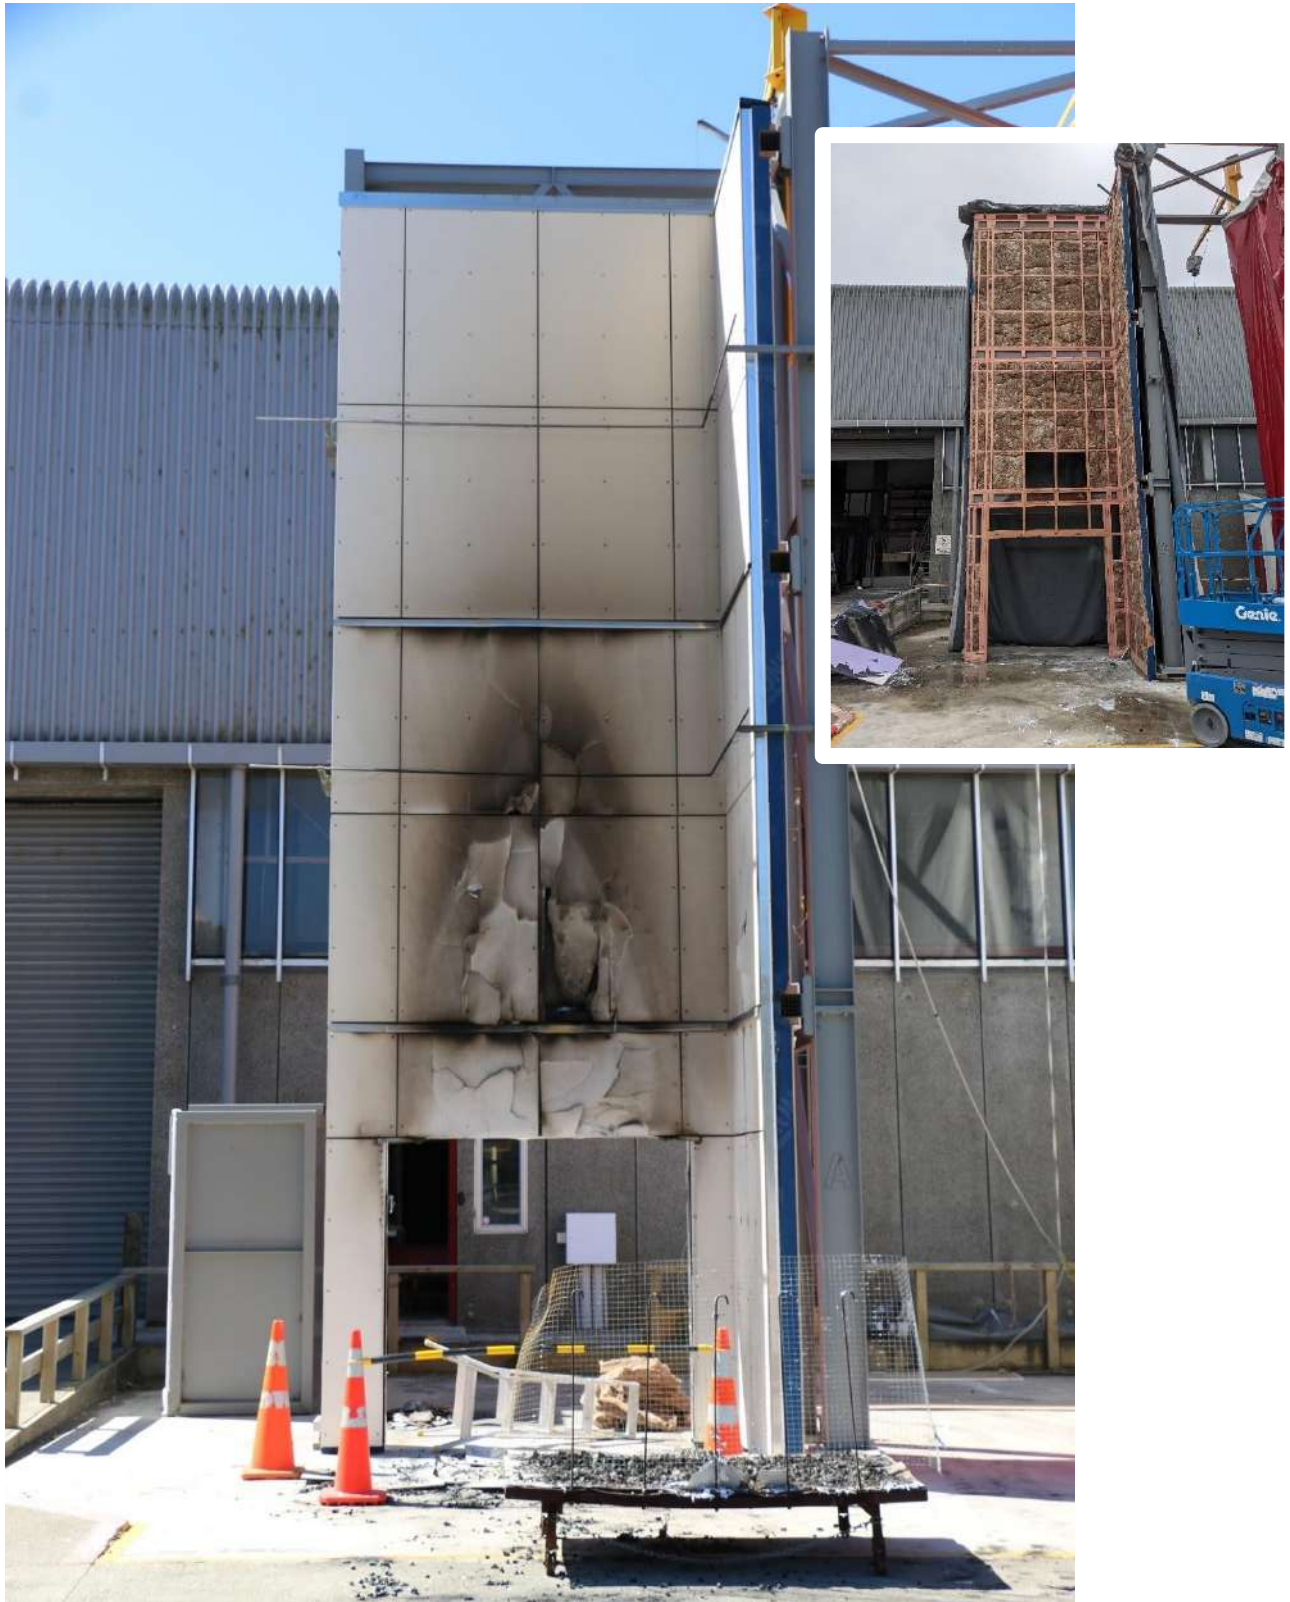
Cladding sheets 2.5 m above the chamber head delaminated and fissured. There were no signs of detached debris. Fixing rivet sleeves located 500 mm above and below the chamber head height, melted and dripped down the cladding surface.

Photo 32: Post-test main wall: cladding, inset: timber frame

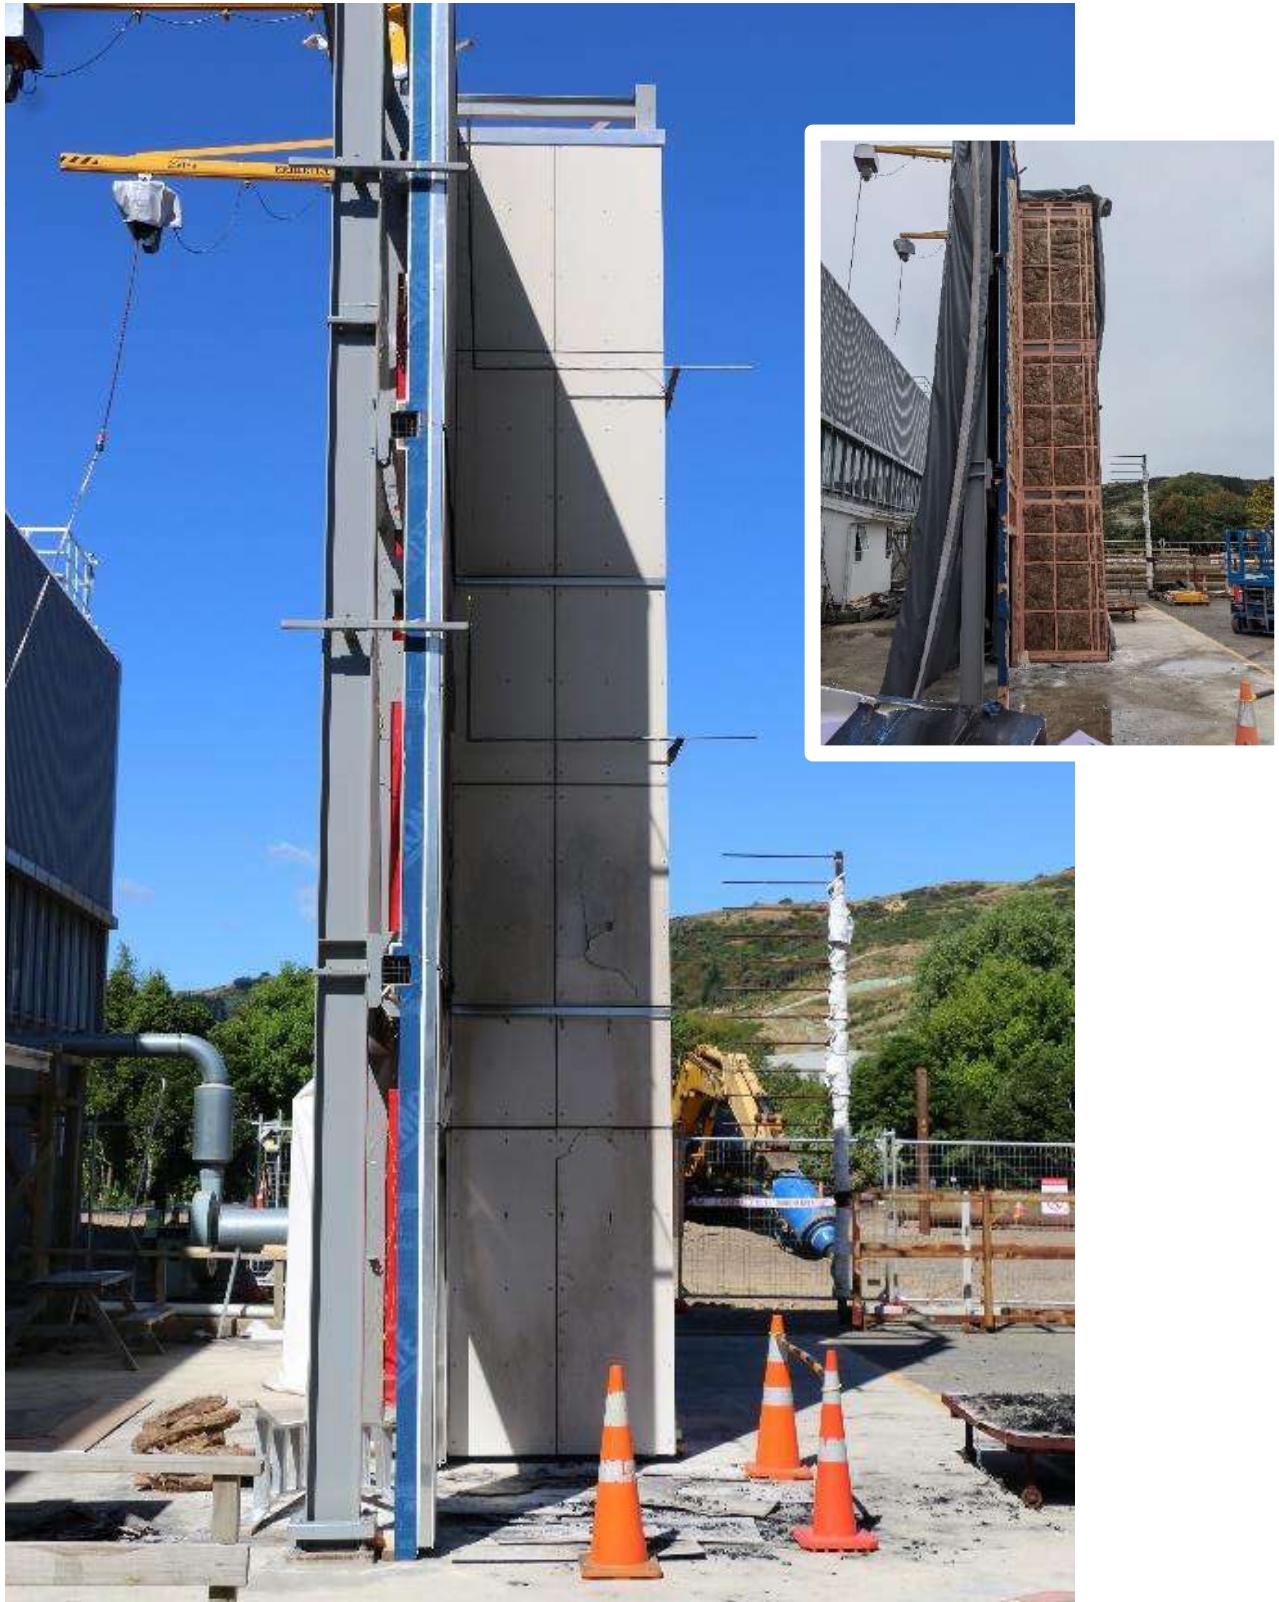
Photo 33: Post-test wing wall cladding, inset: timber frame

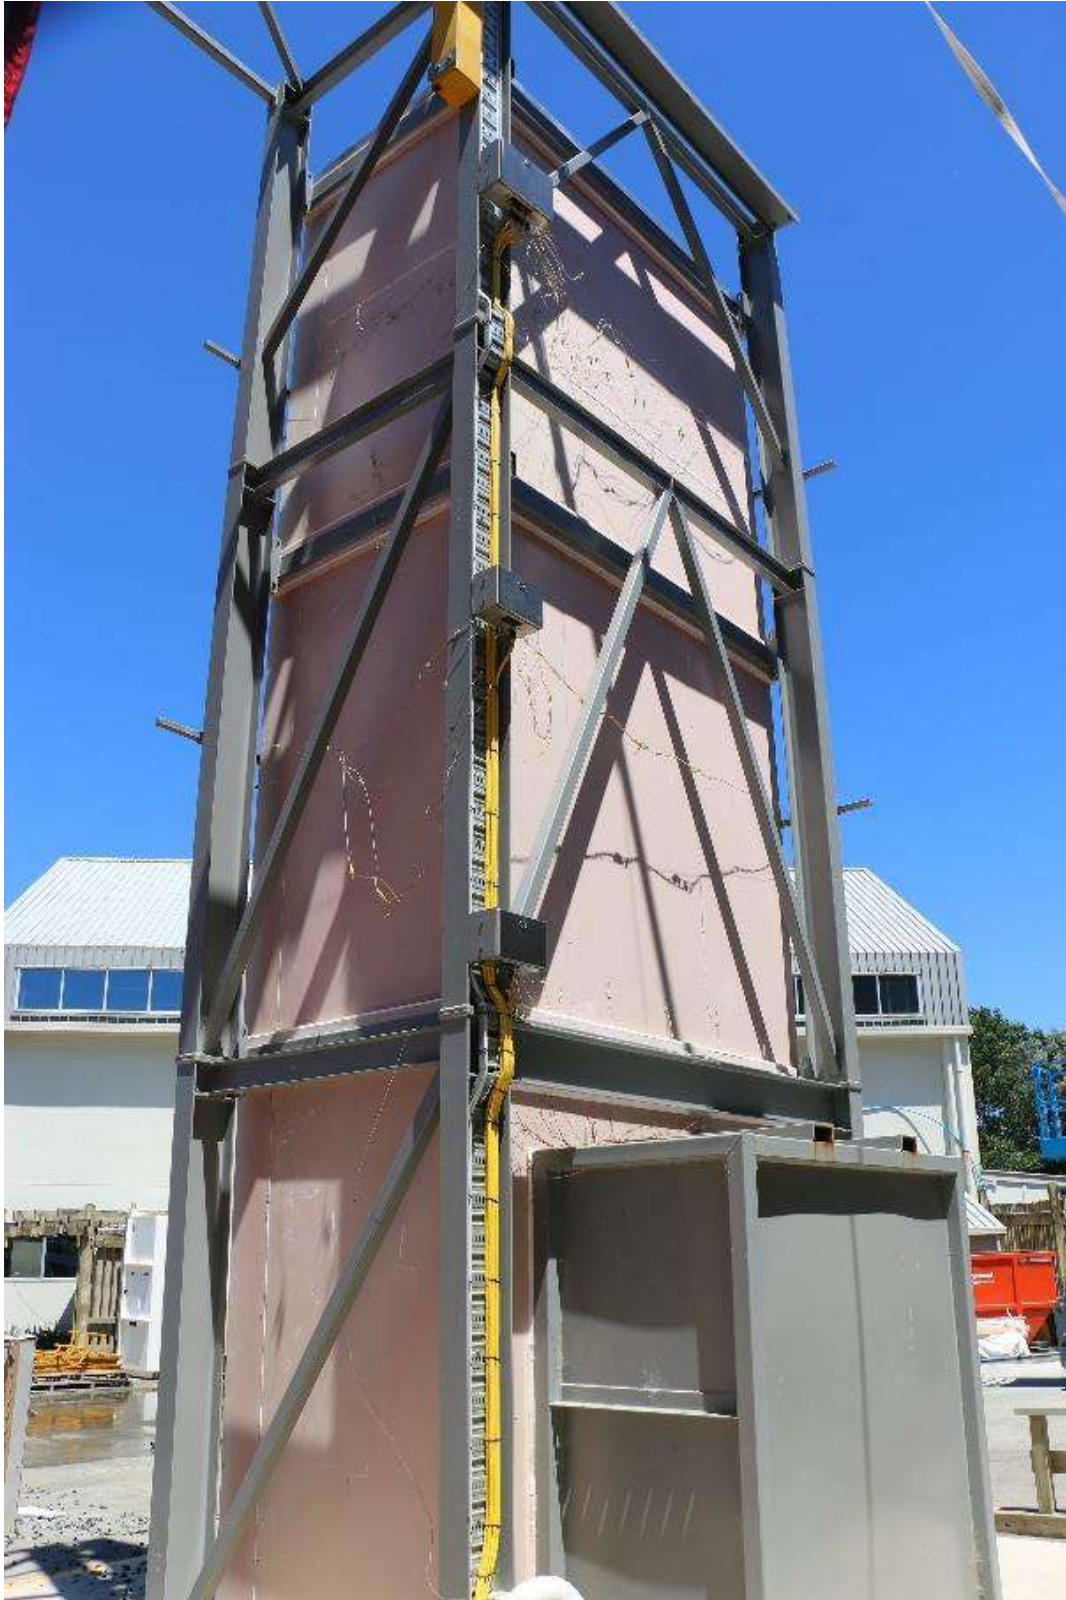
Photo 34: Post-test unexposed surface
