REFERENCE: Symonite Panels Ltd
PO Box 101-760
North Shore
Auckland 0745

Performance tests on Symonite composite Aluminium cladding system in accordance AS/NZS 4284: 2008 Testing of Building Facades.

DATE OF TEST: 14 - 16 July 2014

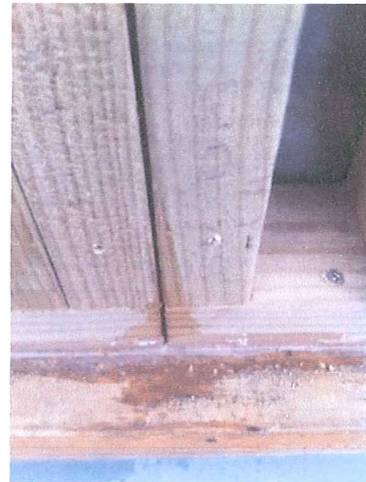
During the preliminary static water penetration test, water penetrated through open joints in the framing bottom plate, due to a leakage path through the bolt holes in the bottom timber portal plate of the test enclosure. This allowed water to penetrate to the underside of the framing bottom plate, tracking along to the open joints of the test framing bottom plate. The client applied sealing tape to the re-entrant corner between the test enclosure steel base and the portal plate to eliminate the leakage, as shown on Drawing "M".

The issue at the bottom plate was found to be that the portal plate is not fully sealed to the steel structure allowing air/water to track between the portal plate and the steel, penetrate through the bolt holes to the underside of the bottom plate. From there the air/water found a route under the bottom plate to the cut in the bottom plate and through any other imperfections along the portal plate causing the leak. As the root cause of this leak is not associated with Symonites panel system, no panels were removed or altered. A remedy was effected by applying flashing tape to the underside of the portal plate and down onto the structural steel.
