TEST REPORT No. 14/06B

REFERENCE: Symonite Panels Ltd
PO Box 101-760
North Shore
Auckland 0745Performance tests on Symonite composite Aluminium cladding system in
accordance New Zealand Building Code E2/VM1:**DATE OF TEST:** 18 - 19 July 2014**SUMMARY****Series 1 Static pressure Water Penetration Test:**

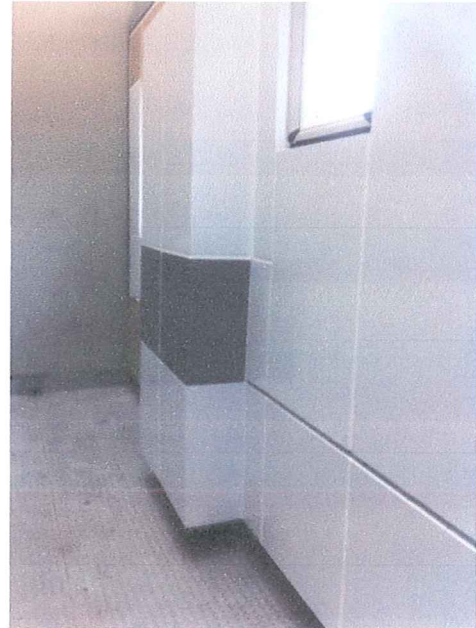
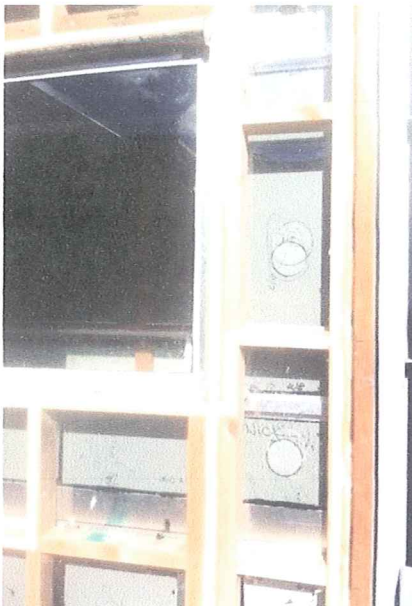
The Symonite composite aluminium cladding system consists of a nominal 4mm thick panel with pre-coated aluminium faces and a composite polymeric core, which is fabricated using V groove machining and folding into individual panels. The panels are fitted together with overlapping horizontal and vertical joints, incorporating aluminium extrusions riveted to the inner edge of the panel edges and fixed onto the support framing. With the exception of horizontal drained joints, all horizontal and vertical panel joints are subsequently filled with silicone sealants on PEF backing rod.

E2/VM1 the previously installed transparent rigid air barrier of 4.5 mm clear polycarbonate sheet was retained instead of a flexible building wrap.

However to comply with the principle of E2/VM1 which uses a full internal lining together with a possibly permeable building wrap, 100 mm diameter openings were cut through the 4.5 mm polycarbonate sheet at every frame opening except for those designated as viewing points for the Series 1 & 2 water penetration tests. The remainder of the internal face was lined with plywood, leaving the original section of polycarbonate at each internal view point opening.

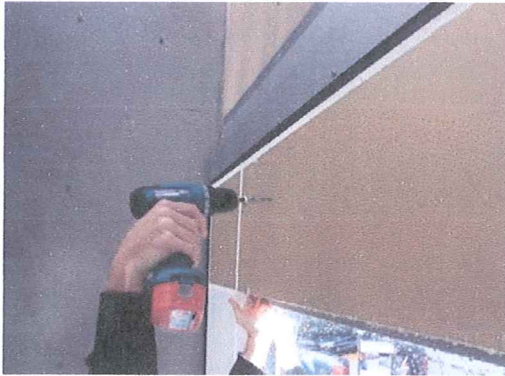
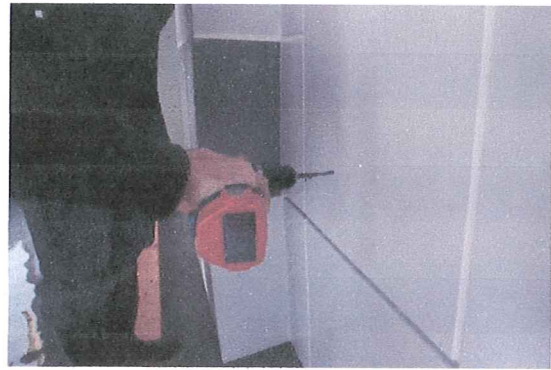
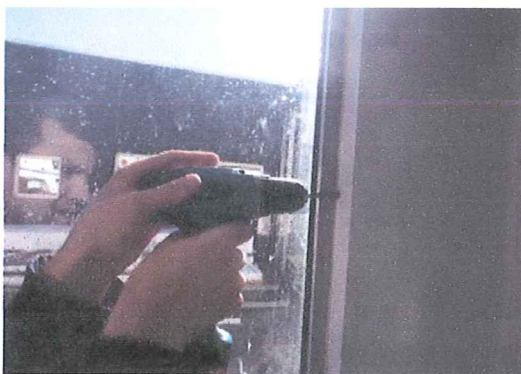
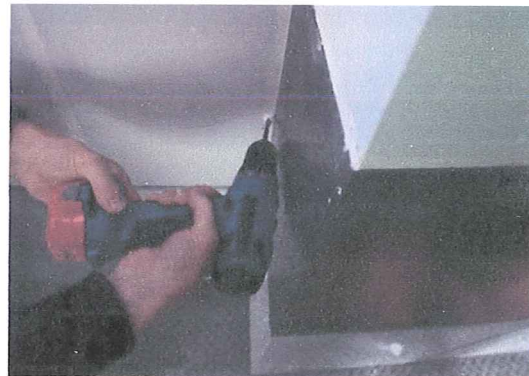
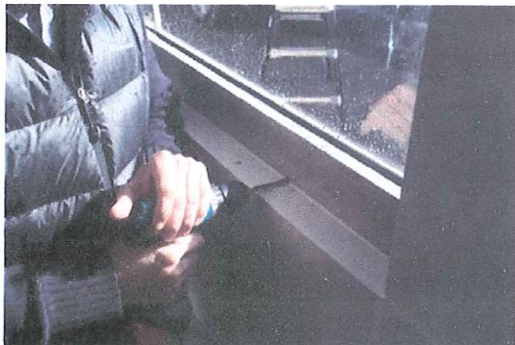
The following photos show the locations of the specified 6 mm diameter holes drilled for the Water Management test.

The initial Series 1 test is specified as a 15 minute exposure to a static pressure of 455 Pa, followed by two sequential periods of 5 minutes at cyclic pressures of 227 - 455 Pa and 455- 910 Pa respectively. The Series 2 Water Management test consists of a repeat of the static and cyclic Series 1 pressure sequence following the drilling of several 6 mm holes through the cladding face simulating possible defects in the external seals or cladding.

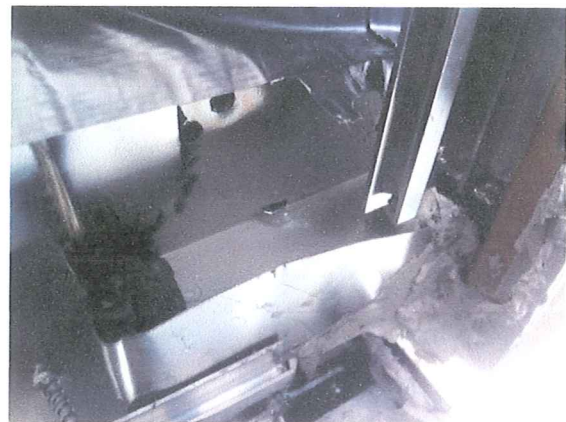
As the results below indicate, water penetration onto the plane of the building wrap was visible during the Series 3: Wet Wall Test Static Water penetration test. The clients subsequently removed the adjacent external panel and located a hole in the back corner of the head flashing that was allowing water to flow into the rear of the cavity, onto the plane of the building wrap. It was apparent that the head flashing damage had

Hole in rear of head flashing

occurred following repairs to the window sill installation after water penetration occurred during the AS/NZS 4284 preliminary tests.

<p>Series 3: Wet Wall Test Static Water penetration Test pressure 50 Pa Duration 15 mins</p>	<p>Water penetration around window head flashing, crossing cavity onto plane of building wrap. No other water transfer to plane of building wrap</p>

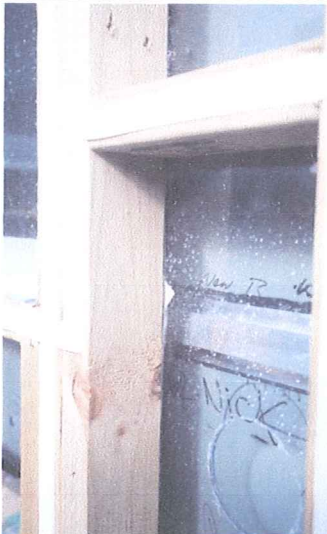
Retest following repair to window head flashing

Series 3: Wet Wall Test Static Water penetration Test pressure 50 Pa Duration 15 mins	No water penetration around window head flashing, No water transfer to plane of building wrap
--	---
