BRANZ **FIRE TEST REPORT**

FF13923-01

**BS 8414-2:2015+A1:2017 TEST OF EQUITONE T50 FAÇADE SYSTEM
IN ACCORDANCE WITH BR 135 ANNEX B CRITERIA**

The Building Agency
14 Link Drive
Wairau Valley
Auckland, 0627
New Zealand

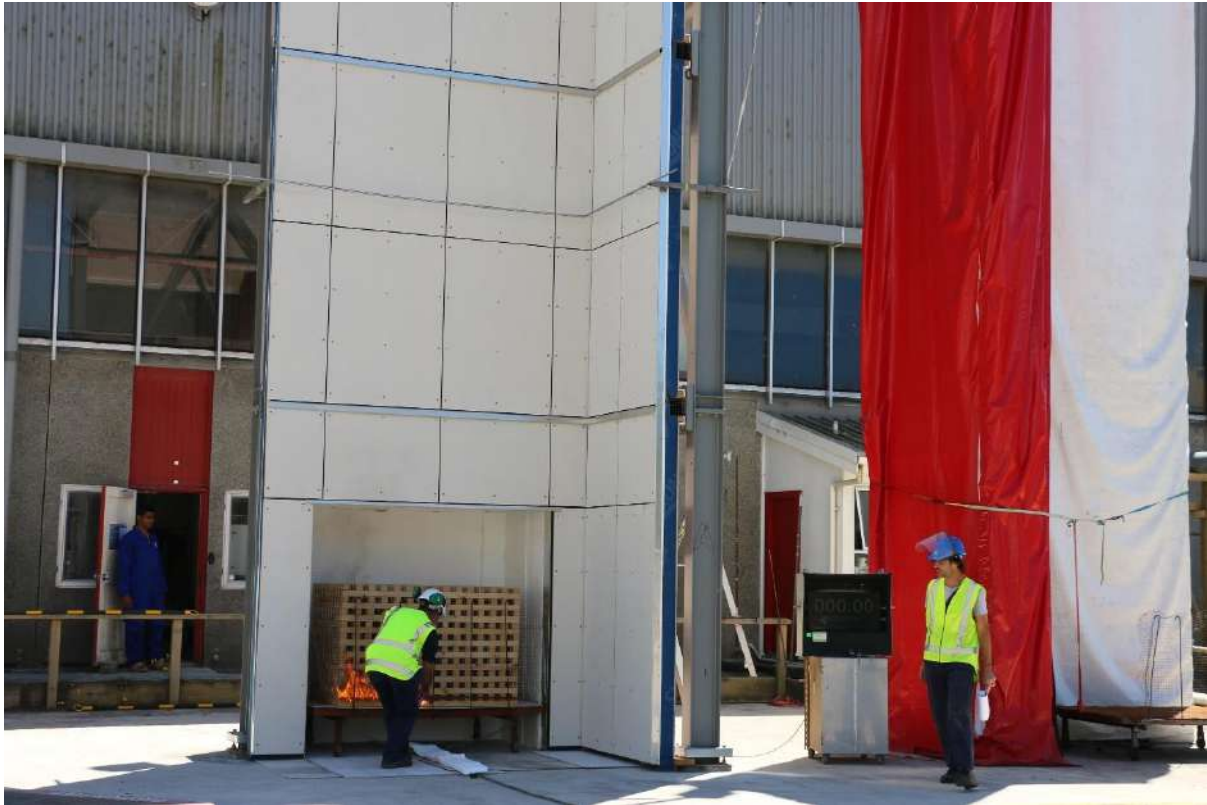
Photo 20: Ignition of timber crib

Time (Min:Sec)	Observations
00:00	Timber crib ignited.
00:05	Large plume of black smoke billows from chamber as white spirits burn off.
00:55	Flames emitted from chamber approximately 1 m high.
01:05	Start time criteria t_s achieved.
01:35	Distortion of head flashing and drainage cavity flashing centrally above chamber.
02:30	Smoke from white spirits has ceased.

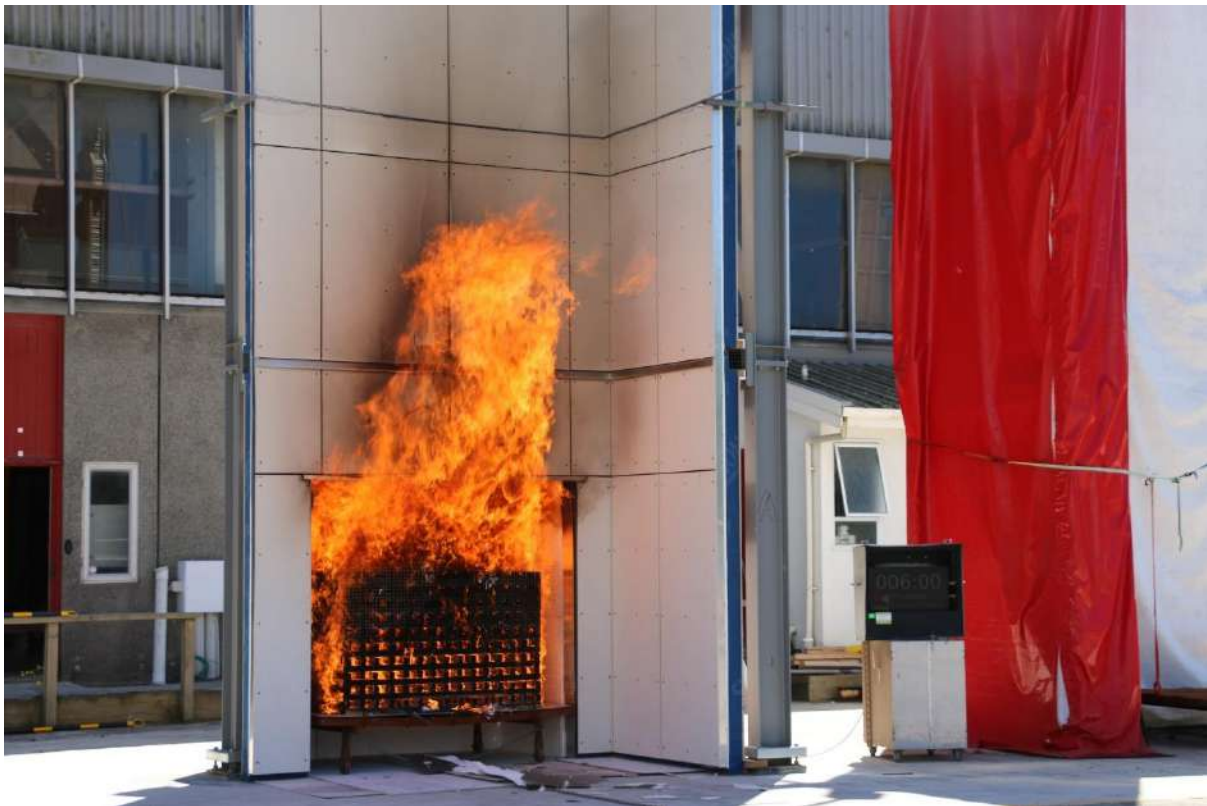
Photo 23: At 6 minutes 0 seconds

04:48	Flaming droplet falls from head flashing, unsustained flaming on contact with ground.
05:07	Explosive spalling of cladding panel above the drainage cavity flashing central to the chamber. Delamination of 0.7 x 0.4 m section of the panel.

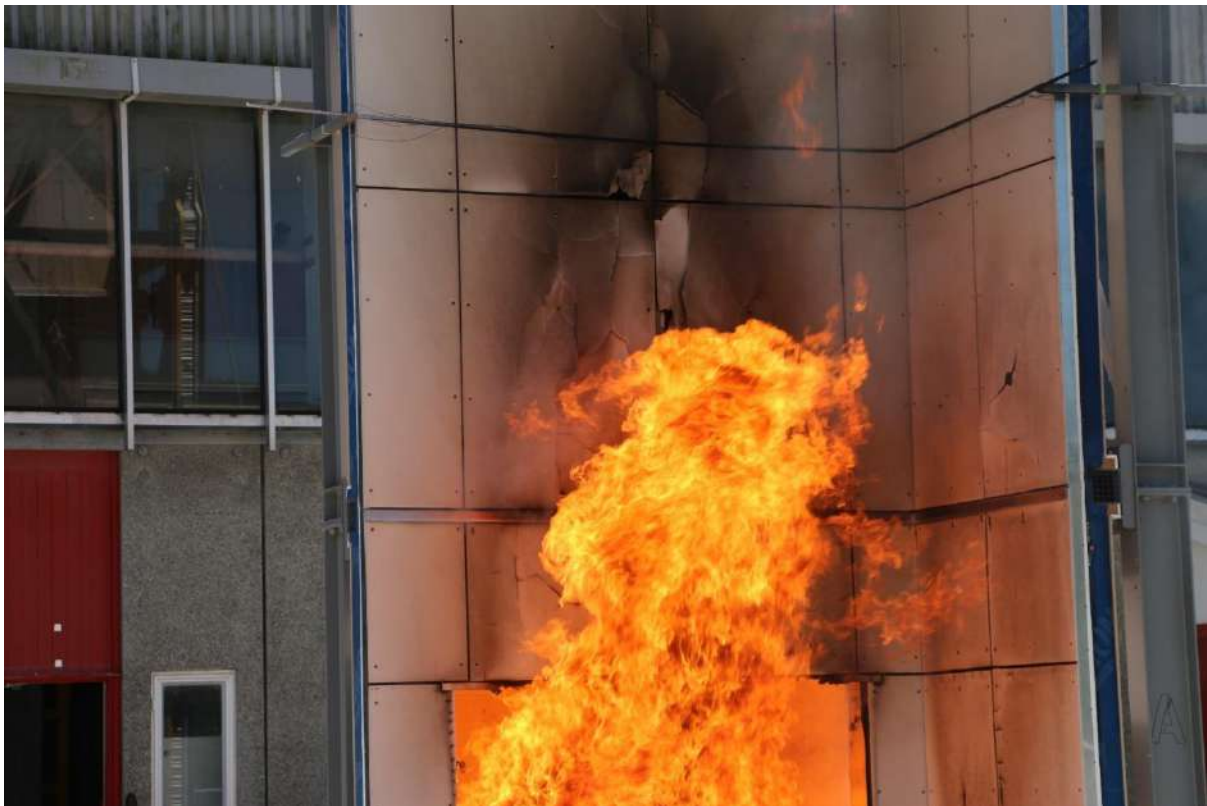
Photo 29: At 17 minutes 0 seconds

15:00	Smoke has begun to expell from the parapet capping at the top of the main wall.
17:30	Flaming debris from timber crib burns on ground at the base of the main wall.
